Make: HYUNDAI

Model: ILOAD

Year: 2014

VEHICLE PRE-PURCHASE INSPECTION REPORT

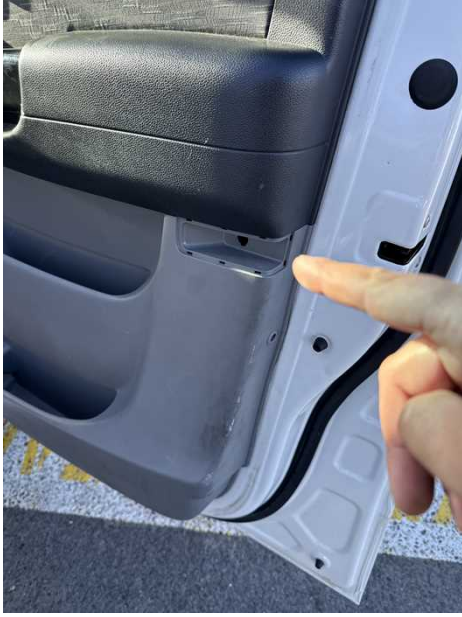
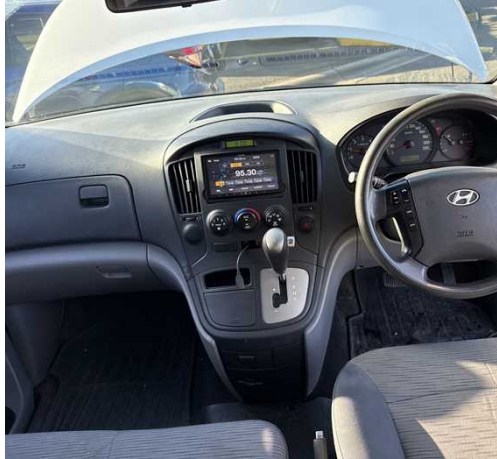
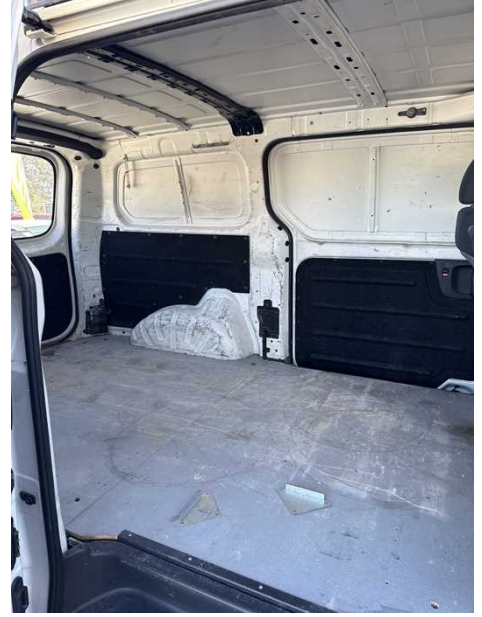
INTERIOR

Passenger side (left hand) sliding door does not lock or unlock via central locking (remote), needs to be manually unlocked and locked

Aftermarket head unit (radio) fitted

Some trim scuffs and missing reflector on inside of door

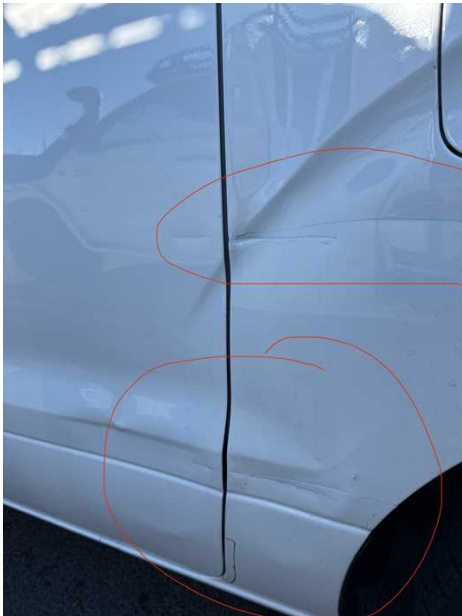
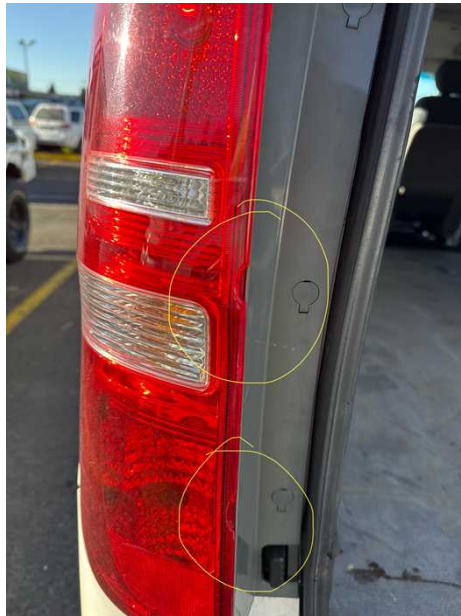
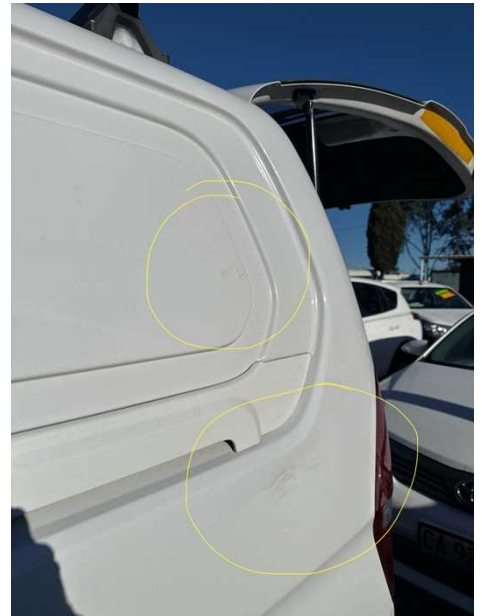
EXTERIOR

Some dings found on some panels,

Some damage on passenger side sliding door and rear quarter panel (refer to photos) appears to have some touch up paint on it

Small chips in left tail light

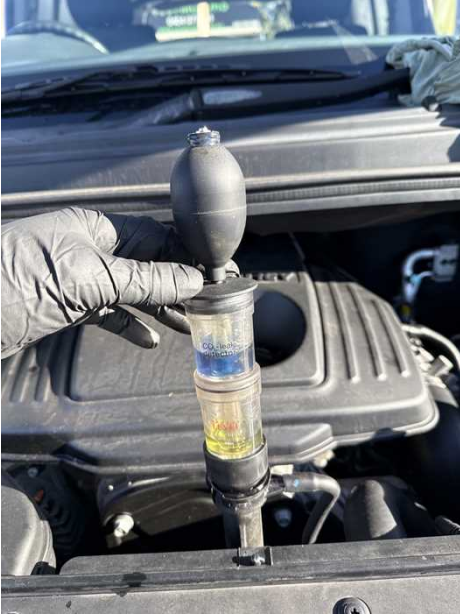
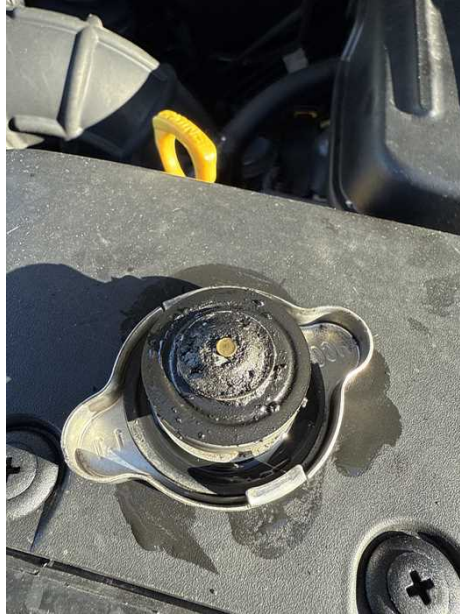
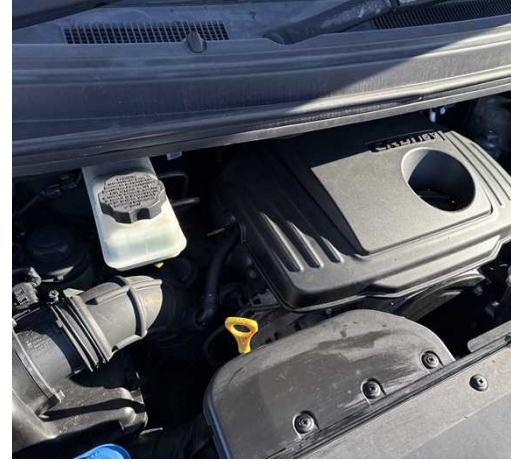
ENGINE BAY

Engine bay very clean as detailed, hard to detect if there is any oil leaks

Performed tk combustion leak test, appears to be ok at time of inspection (refer to image)

Radiator cap has black substance on it, recommend replacing radiator cap (refer to image)

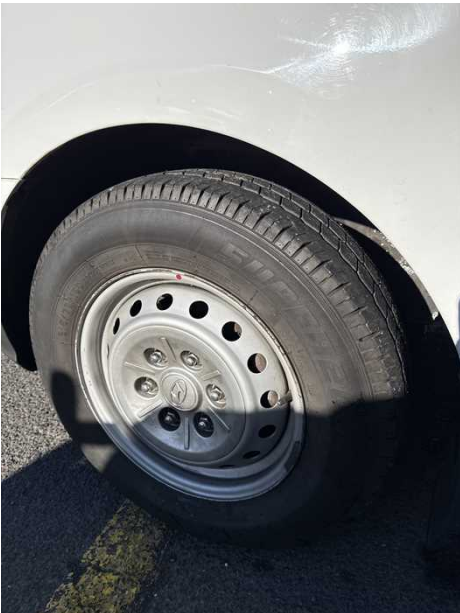
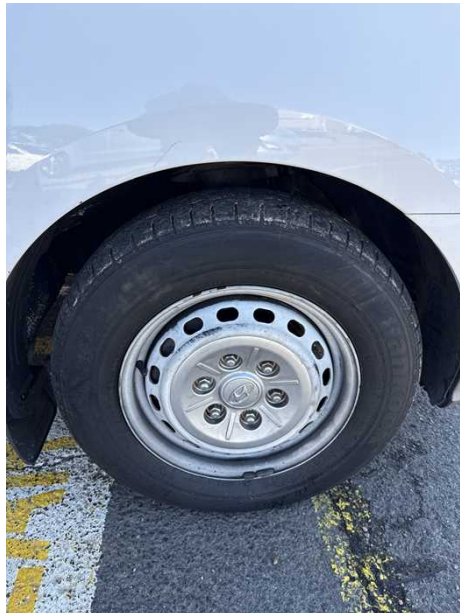
TYRES, WHEELS & BRAKES

Appear to be all ok at time of inspection

Some scuffs on wheels
