Make: HYUNDAI

Model: ILOAD

Year: 2014

VEHICLE PRE-PURCHASE INSPECTION REPORT

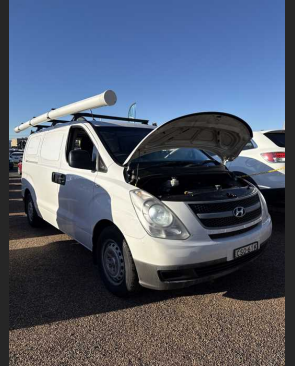
INTERIOR

Passenger side (left hand) sliding door does not lock or unlock via central locking (remote), needs to be manually unlocked and locked

Some trim scuffs and missing reflector on inside of door

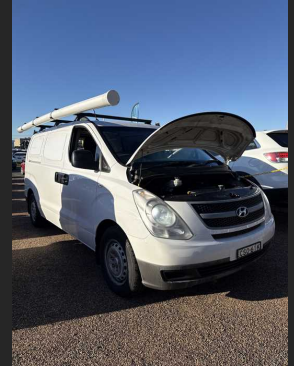
ENGINE BAY

Performed tk combustion leak test, appears to be ok at time of inspection (refer to image)

Radiator cap has black substance on it, recommend replacing radiator cap (refer to image)

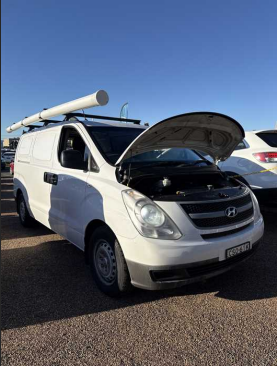
ROAD TEST

Logbook records stop at around 160,000km. and missing the first 80,000km
